### McClellan Air Force Base

Finding of Suitability to Transfer

Capehart Military Family Housing and Lawrence Links Golf Course

January 2002

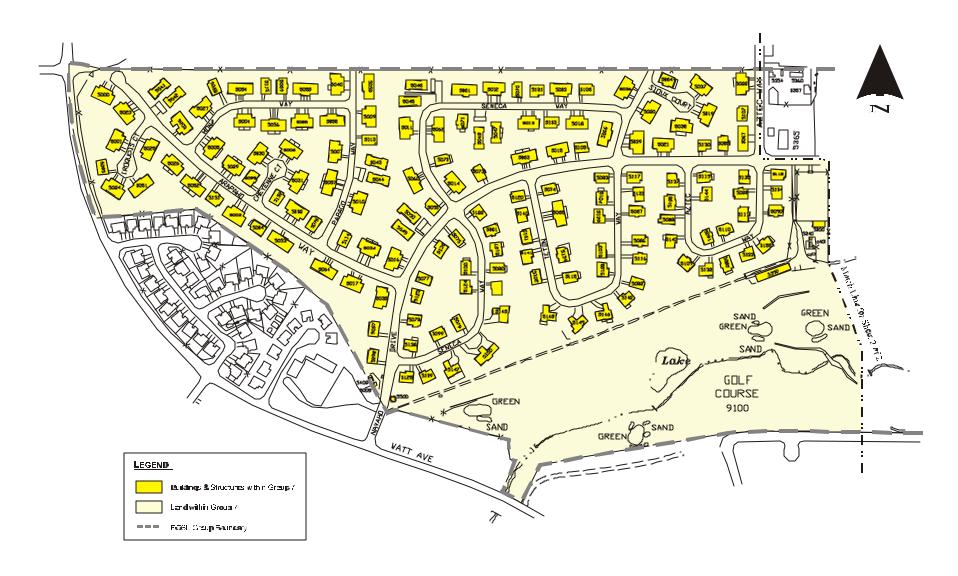
Figure 2 Sheet 1 of 2

# FOST CAPEHART MILITARY FAMILY HOUSING AND LAWRENCE LINKS GOLF COURSE PROPERTY FOOTPRINT LOCATION

- 1. Fig. 1 Capehart MFH and Golf Course Property Location Map (1 page)
- 2. Fig. 2 Facility Location Map (2 pages)
- 3. Environmental Factors Considered
- 4. Notice of Hazardous Substance Release
- 5. Data Gap Summary Memorandum dated December 1999
- 6. Environmental Condition Report, dated February 2001
- 7. Regulator Letters
- 8. Response to Regulator Comments
- 9. December 2001 VSI

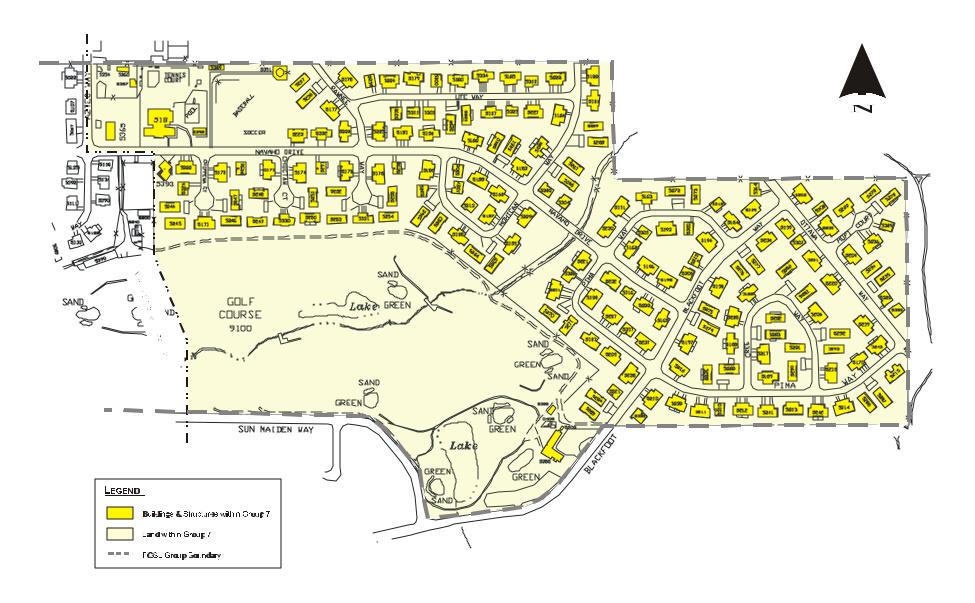
Figure 2 Sheet 2 of 2

# FOST CAPEHART MILITARY FAMILY HOUSING AND LAWRENCE LINKS GOLF COURSE PROPERTY FOOTPRINT LOCATION
